SHOP TALK

VOLUME 1

CHAPTER 4

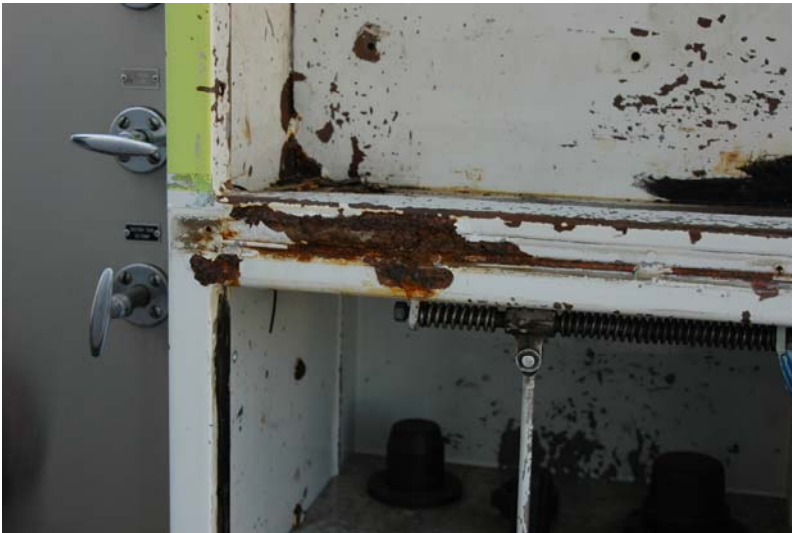
Dividing Rail (rust damage)

None of these problems were very big and not much damage to the apparent material of the truck. The first thing we chose to work on is the dividing rail. We took a disc grinder and ground out all the rust down to the bare metal. After we removed all the rust we filled in the low spots with weld. We used a .035 wire welder and made small weld areas until able to build up all the low spots. Once this was archived we took the disc grinder and ground the material flat.

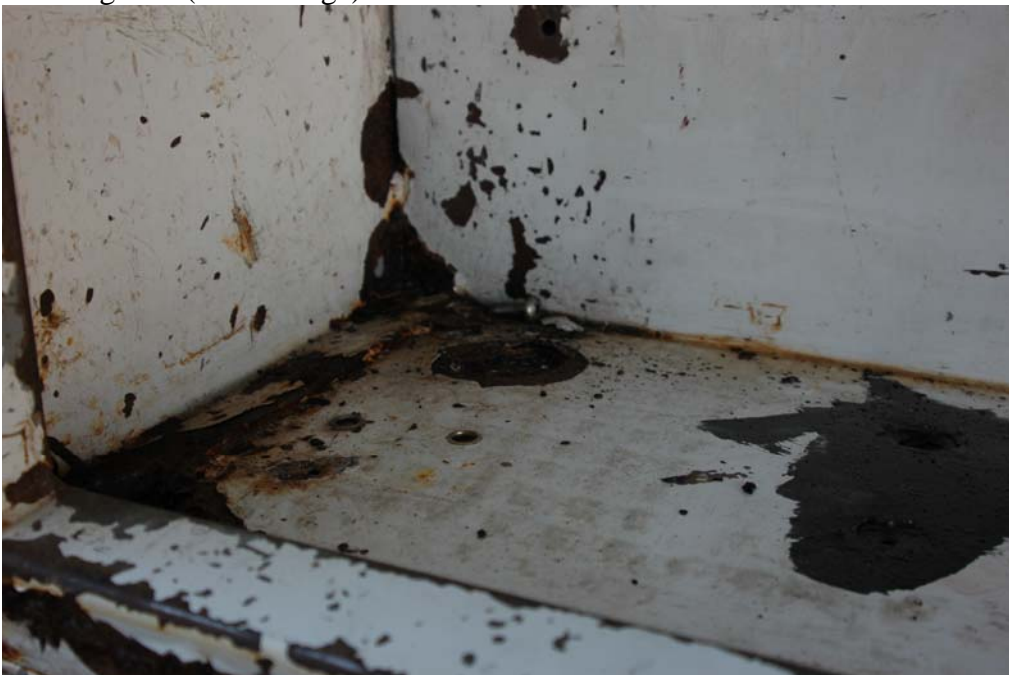
Inside front cabinet damage.

On the inside of the cabinet we took the same approach. We ground and welded the bad spots, and then we used aluminum diamond plate which we had precut to size and then riveted it into place.

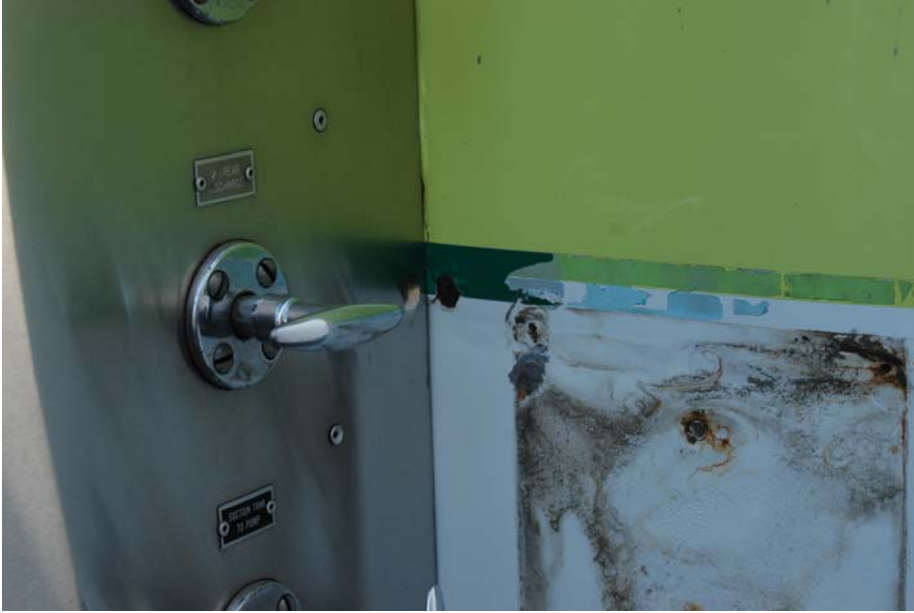
Front cabinet damage.

We did the same thing with the front of the cabinet. The small hole was ground out and welded up. Then we purchased panel plates cut to size. The front piece was a 304 stainless 2B finish 1/16 thick. After trimming the plate to size we riveted the plate in place.
