SHOP TALK

In this issue we are going to deal with a rusted out support under a side cabinet of a fire truck.

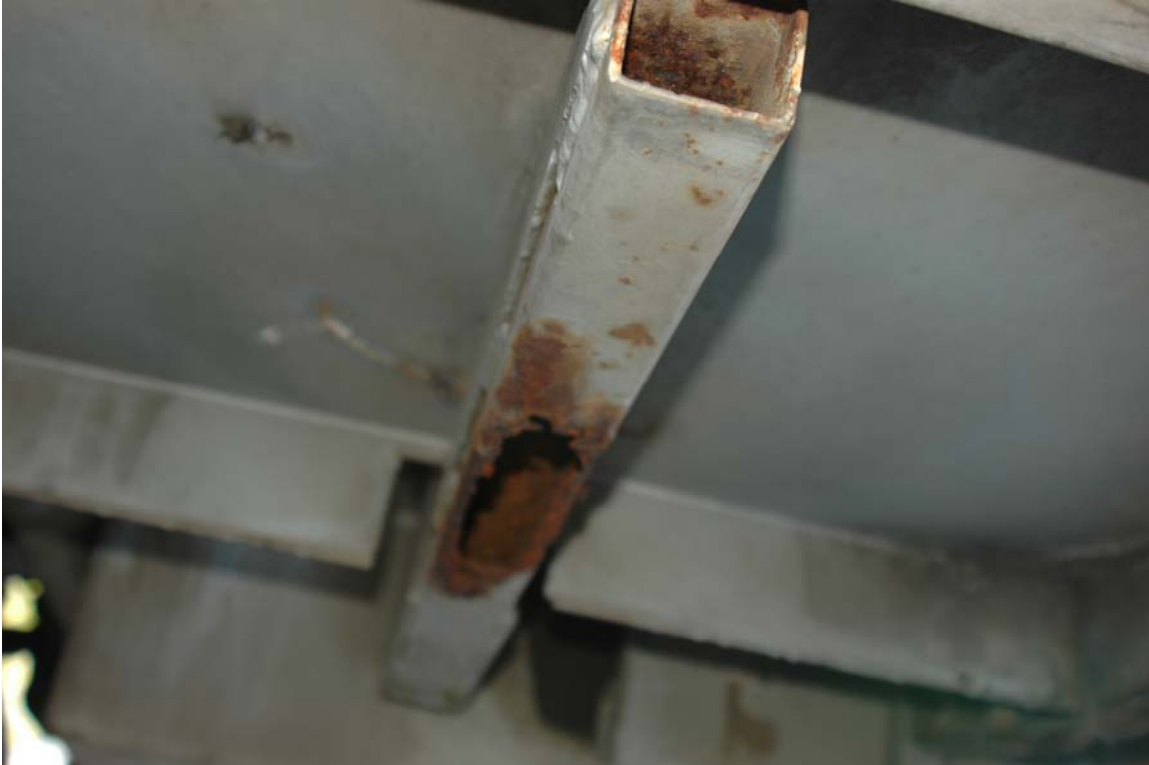
The first thing is to identify the problem and identify the material that you need to fix the problem. What we have here is a basic 2"x 2"x1/8" steel tubing, a piece of 1/4" x 2" angle. We can see by the crack in the rear where the bottom of the cabinet is welded to the angle that this has created a stress point or pressure point that will need to design a repair to keep this from reoccurring. The angle is welded to the bottom of the cabinet and the tube assy. The tube assembly is bolted in the rear.

The easiest way to remove this is to cut the welds off from the bottom of the cabinet and tube assemblies, by angle using a cut off grinder, and then remove the bolts from the frame of the truck.

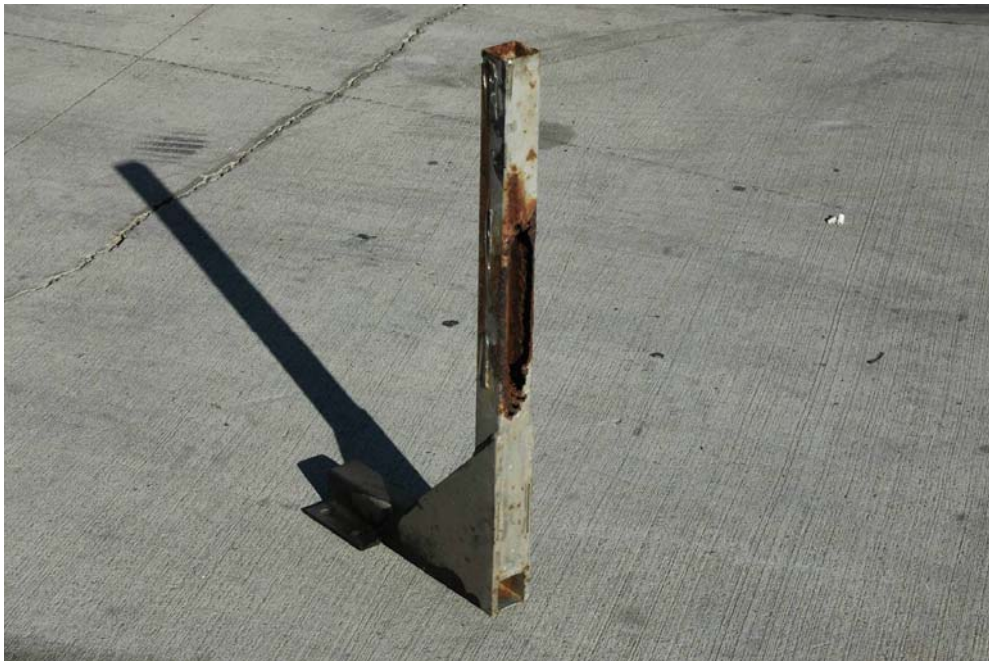
Once we get it out where we can see it most of the assembly. looks pretty good with the exception of the tube. We are going to take our cut off grinder again and grind off the welds that hold the tube onto the assembly.

With the bad tube removed we are ready to cut and weld a new tube back into the assembly.

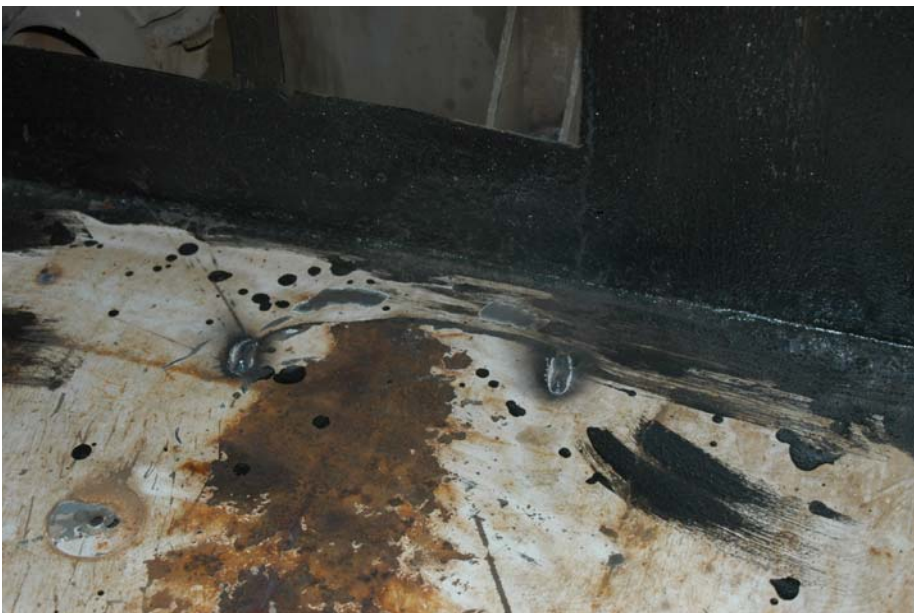
Now we still had a hole in the under cabinet and we want to stop the prior cracks from spreading any farther. For the cracks we are going to take our disc grinder and cut into the crack and a little past the ends of the cracks. Then weld the spots and this will prevent the crack from spreading.

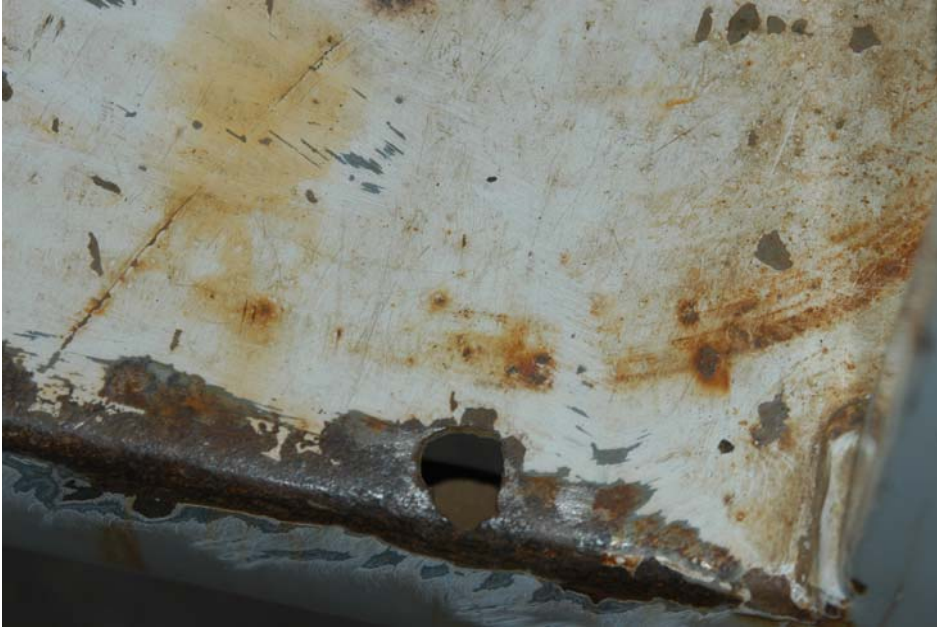
The hole through the bottom is going to be another easy fix.
